HYPERVELOCITY IMPACT DAMAGE INTO SPACE SHUTTLE SURFACES

Ronald P. Bernhard*, Eric L. Christiansen, James Hyde*, Jeanne L. Crews

NASA Johnson Space Center, Houston, Texas 77058

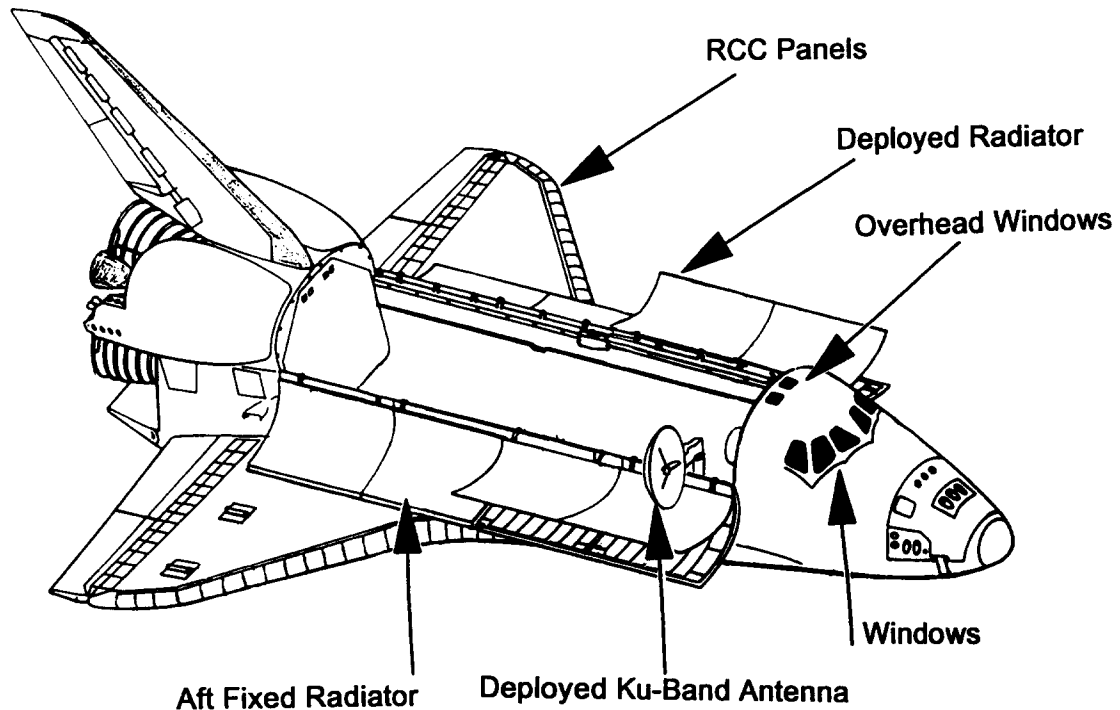
Figure 1. Regions of the Shuttle that contained impact features which were cored for Scanning Electron Microscope and Energy Dispersive X-ray analysis.

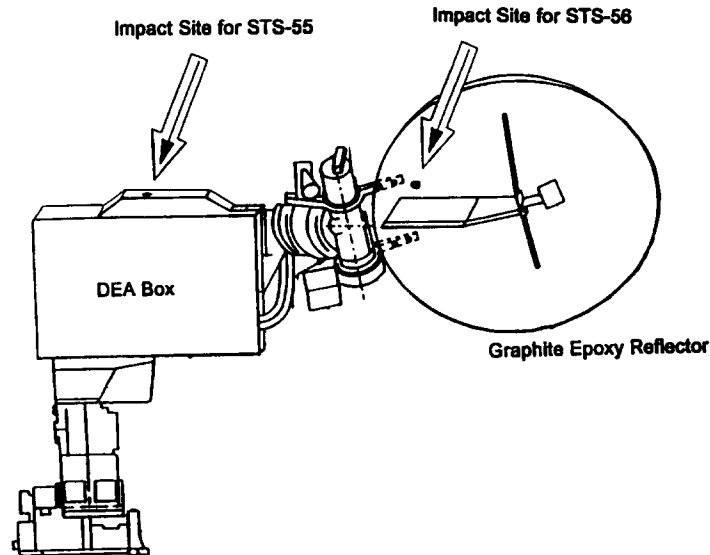
Figure 2. This drawing shows the locations of the two impact sites detected on the Ku-Band antenna structure.

Post flight inspection of OV-103 (Discovery) after STS-56 was conducted to determine severity of impact damage caused to the exposed exterior surfaces. Examination of the Graphite Epoxy Reflector for the Ku-Band Antenna revealed a hypervelocity impact 1.4mm in diameter penetrating the 0.4mm thick graphite epoxy structure (figure 2).

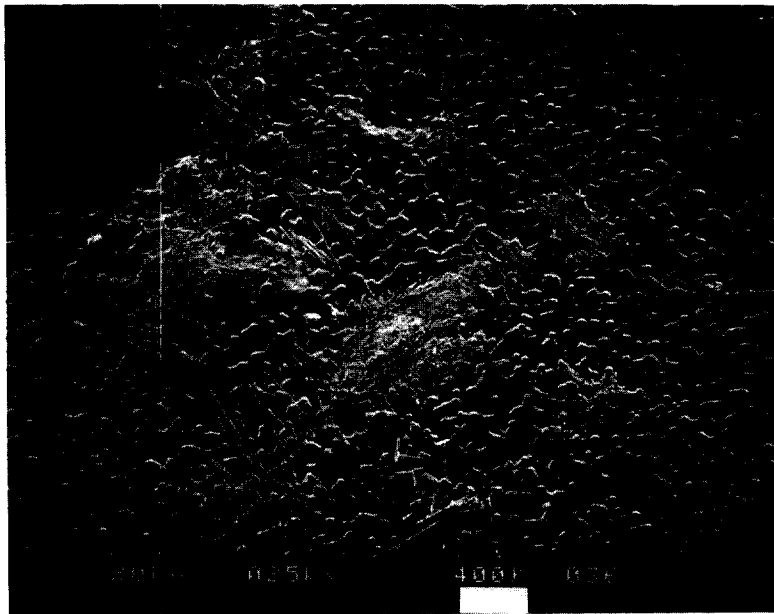
Figure 3. SEM image of the residue collected on a tape pull sample, large flakes and fibers from the graphite epoxy structure are clearly present

The tape pull analysis revealed that some large amounts of graphite (carbon) material fibers (figure 3), and globular mineral like grains were present at some of the tape sampling locations. The globular appearance of these small particles indicates that materials were exposed to high temperatures producing partial melts. The major elemental constituents in the mineral grains were silicon, magnesium, aluminum, iron, and also potassium which indicate the source of impact was meteoritic in origin (figure 4). In addition, many graphite fibers which may have originated from the impact debris cloud were detected on tape pull samples taken from the antenna rods on the front of the reflector dish, indicating the possible direction of the impact was back to front.

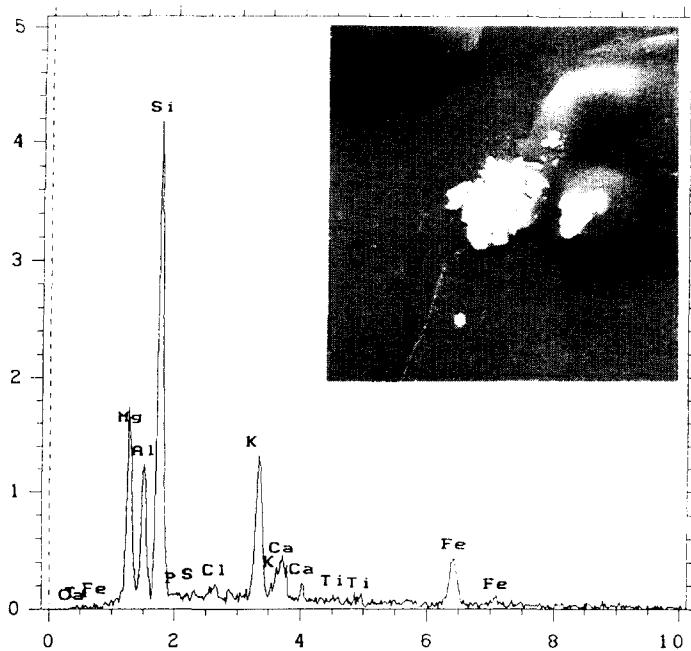
Figure 4. Energy Dispersive X-ray and SEM analysis of residues detected on the DEA antenna impact feature.

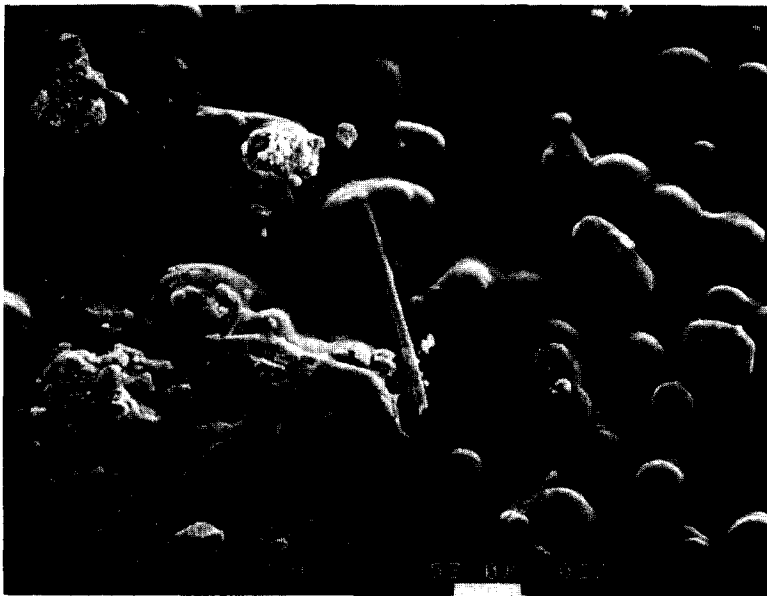
Figure 5. SEM image of residues recovered from a tape pull sample from the DEA Box Cover impact site.

The SEM tape examination revealed large amounts of silicon, and aluminum particles, silver flakes, and sulfur/nickel particles. The major elemental constituents of the remnants detected in EDX indicate that the likely source of these grains are from the DEA Box Cover materials. The components used in the manufacturing and assembling of the Box Cover can be seen in figure 6: the cross-sectional diagram of an impact which helps illustrate the source of such particles. Upon receiving the DEA Box Cover, the impact was

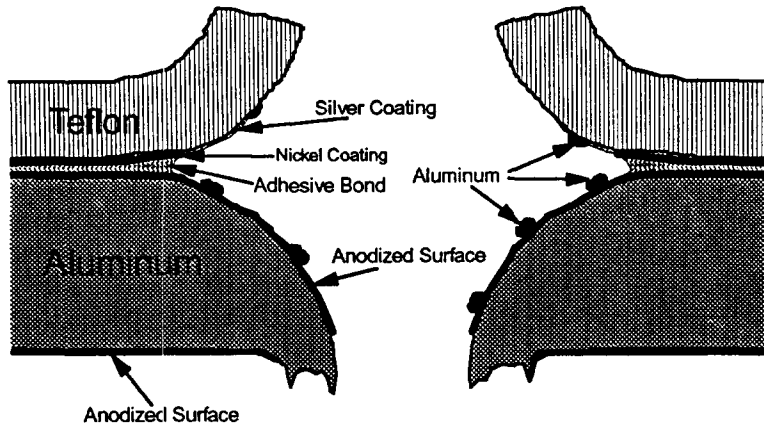
optically photographed and documented. Measurement of impact features are as follows: Teflon delamination zone = 4.07mm; Edge of Teflon hole = 2.58mm; Aluminum crater diameter on front

Figure 6. Cross-sectional view of the DEA Box structure at the area of impact.

facesheet = 1.76 x 1.18mm; Facesheet hole = 0.50 x 0.33mm; Back facesheet spall = 1.39 x 1.11mm. The impact was then cored by using the Long Duration Exposure Facility (LDEF) sample processing press. This provided a 0.50 inch diameter circular sample suitable for SEM/EDX analysis. Preliminary SEM and EDX examination has been conducted on the front and back of the impact (figs 7-8).

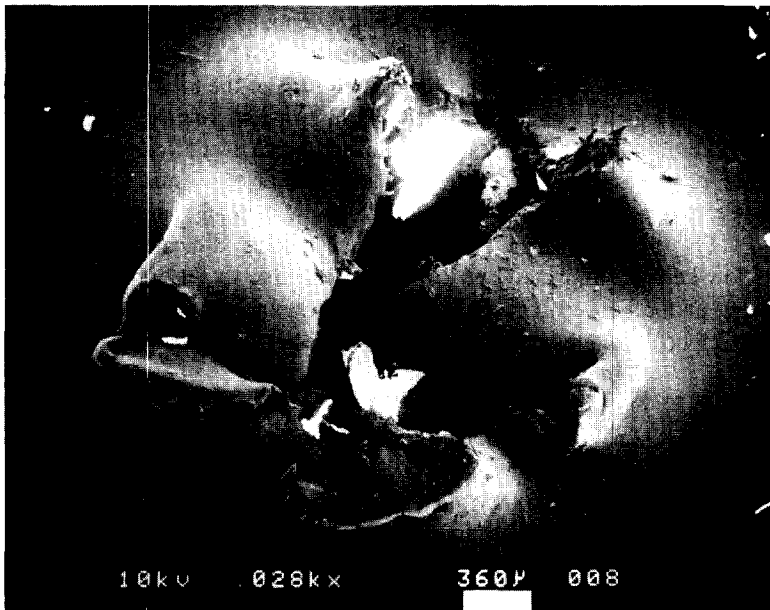
Figure 7. SEM micrograph of the front side (space exposed) DEA Box Cover showing the damaged Teflon and the 400 μ diameter penetration.

the aluminum target material, and that the morphological nature of the residues within the impact indicate that the aluminum melts are most likely remnants from the colliding projectile material. Application of the equations from reference number 12 indicates that if the relative impact occurred at the calculated velocity of 10km/sec and at an angle of 45 degrees from normal (average orbital debris impact conditions), the estimated impactor size would be approximately 0.2mm in diameter.

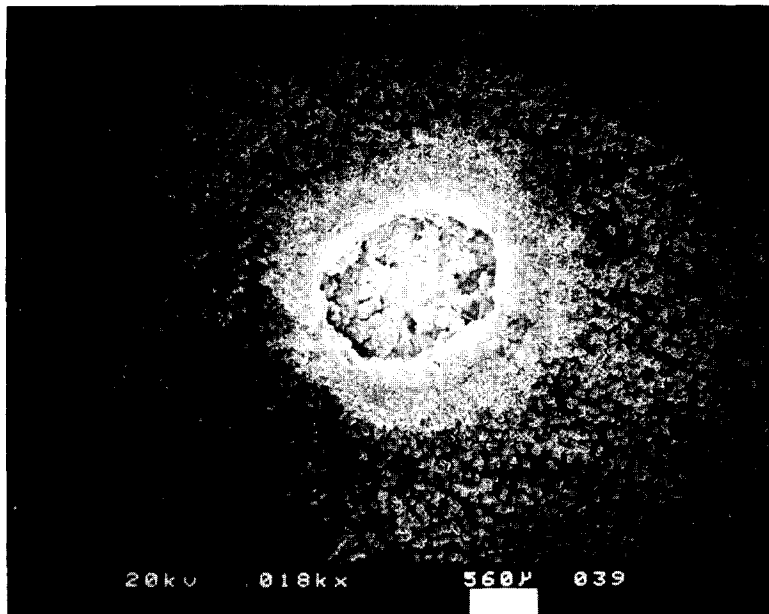
The morphology of the backside exit hole reveals that the penetration was very close to the ballistic limit for this laminated material. High magnification examination also reveals that the anodized layer of the 400 micron thick aluminum has a brittle mud-crack type structure and breaks from the surface when subjected to shock. This anodized surface of the 6061-T6 aluminum contains high levels of sulfur found on both the front and back sides of the aluminum structure. Covering the aluminum was a silverized Teflon blanket 125 microns thick. The silverized Teflon was flash coated with nickel for stabilization and held in place by a silicon adhesive and a Dow Corning primer. Many of the particles detected on and within the impact feature are target components. The Teflon coating was then removed to expose the penetration into the aluminum subsurface. Analysis of the back-side of the Teflon and the interior of the impact hole revealed that the anodized (sulfur) layer on the top-side of the aluminum had undergone only minor deformation, and that the sulfur remained intact. The back-side of the Teflon retained much of the silver coating and some particles found in this region are products of target material. Also detected in this area of the impact, both on the silver surface and the sulfur surface, were particles of aluminum alloy melt. Windowless EDX analysis of these melts show that they are not products from

Figure 8. A view of the DEA Box cover penetration from the backside of the anodized aluminum. The spall zone damage is much larger than the hole damage, and the anodized surface has become pitted due to impact shock stresses.

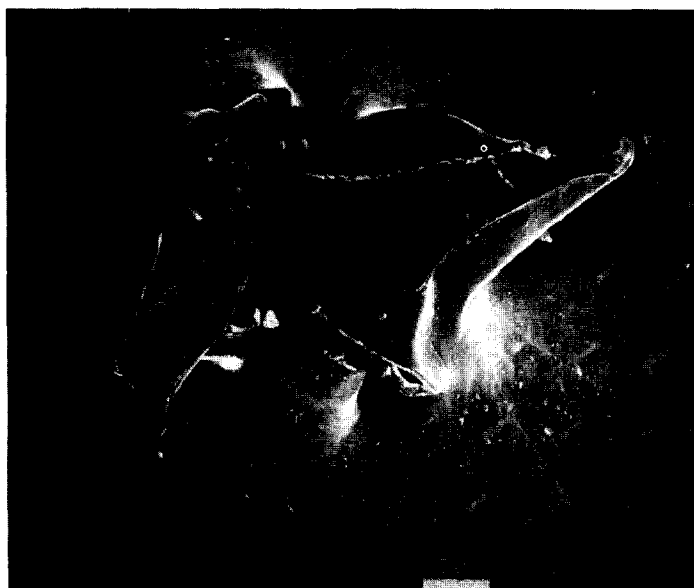
There were 43 hypervelocity impacts found on Columbia's radiators after STS-50. In 17 instances, the impacts penetrated through the silver-Teflon thermal coating and damaged the facesheet of the radiator. In these cases, the silver-Teflon tape was removed by KSC to inspect and repair the radiator facesheet damage. Sixteen tape samples were provided to JSC for SEM/EDX analysis the extent of the damage to each was measured and the results are listed in Table 1. The largest impact on the radiators created a ~3.8mm diameter crater in the silver-Teflon tape and perforated the front facesheet. A total of 4 impacts perforated the front facesheet of the radiator panel. In the remaining 26 impacts, the silver-Teflon coating sustained crater damage but was not completely penetrated. In these cases, the damage was repaired or dispositioned without removing the tape and no sample was available for SEM/EDX analysis.

Table 1 also provides SEM/EDX results. In 6 of the 16 radiator tape samples (38%), the SEM/EDX spectrum indicated that orbital debris was the likely source of the impact damage: 4 with elemental constituents indicating impact by spacecraft paint, 1 by stainless steel, and 1 by a titanium-rich particle (possibly titanium metal). SEM image of the largest impact is shown in Figure 10. This was classified as an orbital debris impact from spacecraft paint because of the large amounts of titanium (paint pigment), silicon, chlorine, potassium, and calcium (inorganic binders) found in and around the impact site. Two of the 4 "paint" impacts had high levels of zinc as well as titanium. In 5 of the 16 samples (31%), material associated with the impact had detectable amounts of elements typically found in cosmic dust meteoroid particles (Si, Mg, Al, Ca, Na, Fe, Cl). In the remaining 5 samples (31%), no detectable remnant projectile material was found. This is due to vaporization of the projectile during impact, and/or

Figure 10. SEM image of the penetration through the radiator panel.

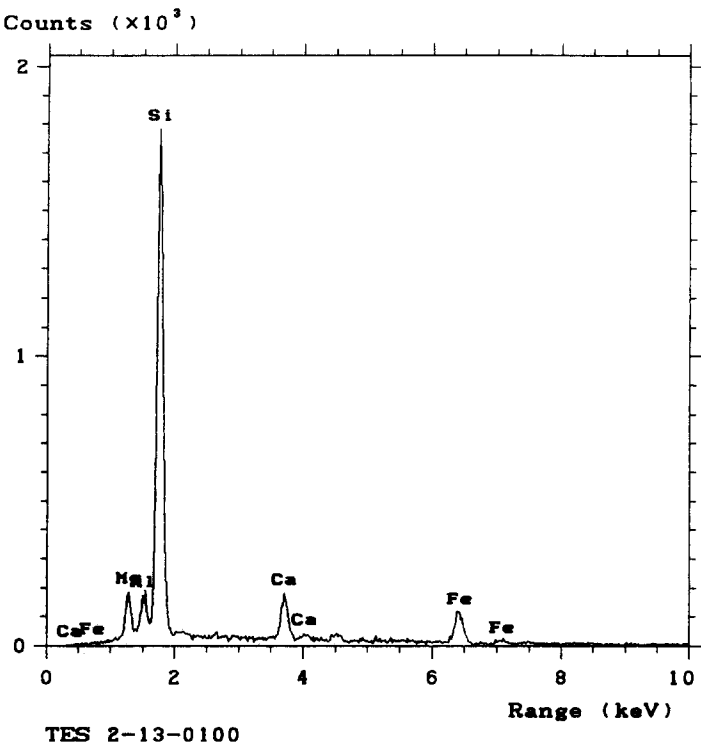
Figures 12. Energy dispersive X-ray spectra of micrometeoritic residues found in impact from figure 11.

Analysis of particles with melt-like morphology found in the largest STS-50 window impact revealed that the impactor was a particle of man-made origin. As shown in the spectrum in Figure 12, the impactor was a titanium rich particle. A small amount of aluminum was also found. Materials of meteoritic origin were found in another impact, while the source of the third impact pit is unknown. Traces of aluminum were found in the third impact site, but because of large amounts of contamination also present, it was not certain that the aluminum originated from the impacting particle. As shown in Table 4, BUMPER predictions compare reasonably well with the total number of hits found on the STS-50 windows, but over-predicts the ratio of meteoroid to orbital debris impacts compared to SEM/EDX results on residues detected within these impact features.
