# Soviet-Russian Tank Turret Armor: The Cold War Shell-Game

by James M. Warford

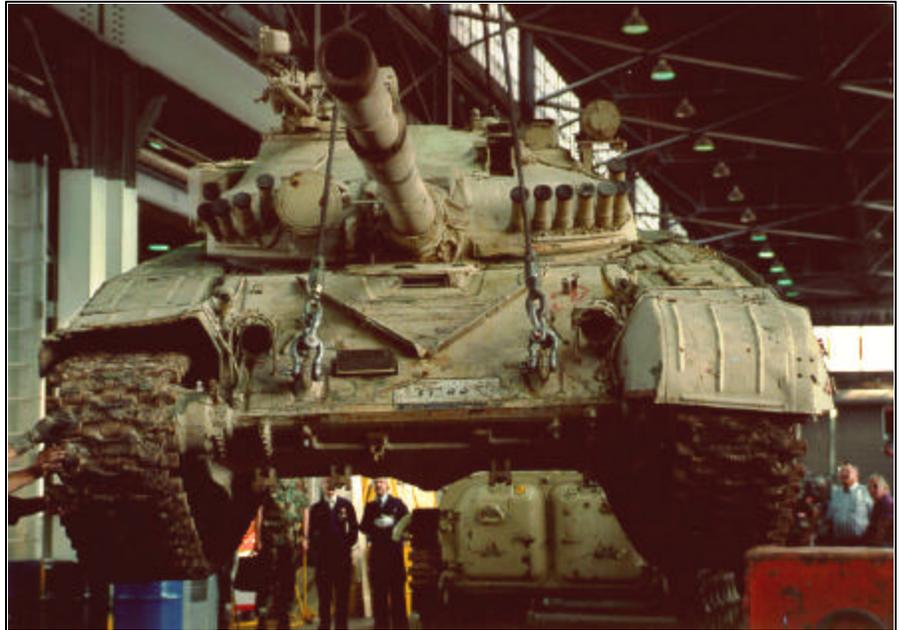
Captured Iraqi T-72s gave Western analysts a closer look at the turret armor of Soviet tanks. This tank was captured by the 24th ID and shipped to the Patton Museum for display. It is seen here being unloaded from a flatcar on arrival at Fort Knox.

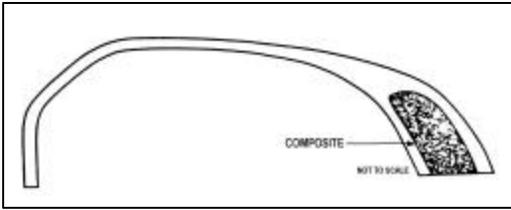
A cut-away, profile view of a possible T-64A tank turret detailing the three-layer composite. (Drawing from USAREUR Intelligence Study: Warsaw Pact Tanks in the Forward Area, regraded Unclassified on December 15, 1998.)

faust and 76mm High-Velocity Armor Piercing (HVAP) ammunition. Additionally, other Russian sources describe the center layer of this three-layer composite as consisting of *peschanye sterzhni*, or “sand rods” or “sandbar.” Based on the possible configuration of the T-64A's armor cavities shown here, designed to tightly confine the composite material, “sandbar” may be the more accurate description. It's important to remember here that the sand in question is probably not typical loose-grain sand. It could actually be a form of silica similar to the “fused-silica” developed as part of a 1952 U.S. program to provide post-war tanks with built-in protection against shaped-charge projectiles, without sacrificing protection against kinetic-energy projectiles or increasing the tank's total weight. Fused-silica composite was selected for this program because it does not “flow plastically” after an impact like steel does. Instead, it rebounds after the shock wave and radially bombards attacking shaped-charge or high explosive anti-tank (HEAT) jet particles and prevents the jet from forming properly — thus degrading or preventing penetration of the tank's base armor. According to *Military Parade*, the official magazine of the Russian

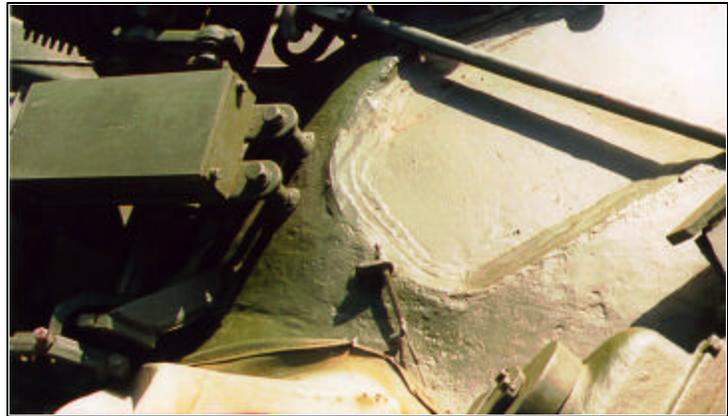
Close-up of the T-90S turret roof detailing the right-side composite armor cavity. Note the depression in the turret roof above the cavity.

While the shape of Soviet tank turrets went through some not-so-subtle changes over the years, these internal cavities remained invisible. The well-kept secret of their existence was unexpectedly made-public with an improved frontal armor design that was incorporated into several of the more recent Soviet Cold War tanks; including the T-72B1, T-72B, T-72S, T-80U, and T-90S MBTs. On these tanks, the cavities actually come through the turret roof, where they can easily be seen when viewed from above. On the T-72B-based variants (T-72B1, T-72S, and T-90S), the cavities have been covered by armor plates inset below the top of the turret, leaving two large depressions in the turret roof.

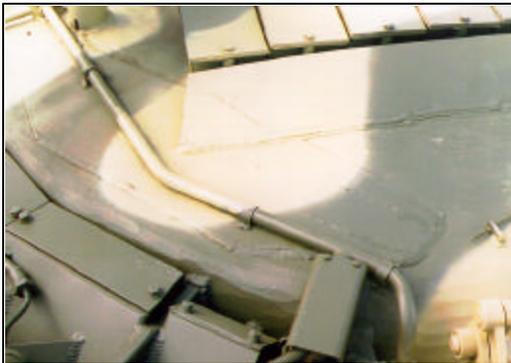
At left, a close-up of the T-80U MBT turret roof detailing the right-side composite armor cavity. Note the cover plate welded flush with the turret roof, thus eliminating the depression.

On the T-80U series (T-80UD, T-80UM, and T-80UK), the cavities are still visible but they are covered by plates that are fitted flush with the turret roof, effectively deleting the two depressions. This

change in turret armor design may have been based on the desire to allow the contents of each cavity to be easily up-graded during the life of the tank.

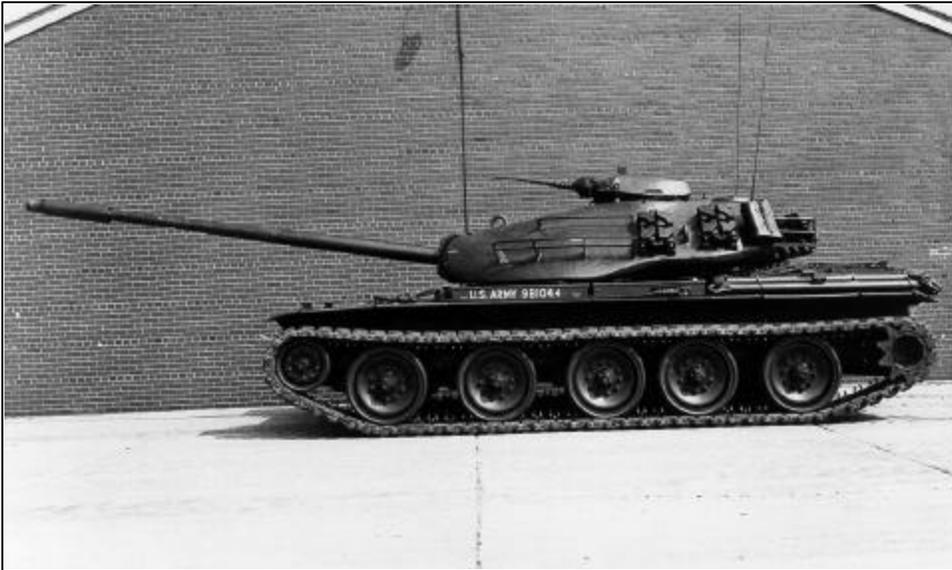
**Pockets in the turret casting of the U.S. T-95, an experimental tank, were filled with fused silica, a form of quartz sand, as an element in the tank's armor protection. It was believed that the silica would protect against HEAT warhead penetration and be no worse than steel armor in defeating kinetic energy attacks. Note also that the track system had no return rollers.**

The reality is that the use of cast tank turrets does not in any way negate the employment of composite armor, a reality that not only the Soviets fully exploited, but one that the U.S. Army tested as well with the U.S. T-95 MBT program (1954-1961). The T-95 prototypes were very similar to the Soviet T-64; in fact, the first and second prototypes of the T-64, the *Obiekt 430* and *Obiekt 432*, appeared during virtually the same time period — 1960 and 1963 respectively.

Combining the T-95 program and the newly developed fused-silica composite

armor resulted in the construction of 36 siliceous-cored T-95 turrets. These turrets were subjected to successful live-fire testing from June 1, 1958 to August 1, 1960. At the completion of these tests, it was determined that fused-silica composite armor provided superior protection against HEAT projectiles, and at least equivalent protection against solid shot armor-piercing projectiles as that of an equal weight of conventional steel armor.
