PENETRATION OF FRAGMENTS INTO AIRCRAFT COMPOSITE STRUCTURES.

G. Jenaro, F.Rey, G.Rosado and P. García

Laboratorio Químico Central de Armamento (LQCA) P.O.Box 1105, 28080 Madrid, SPAIN

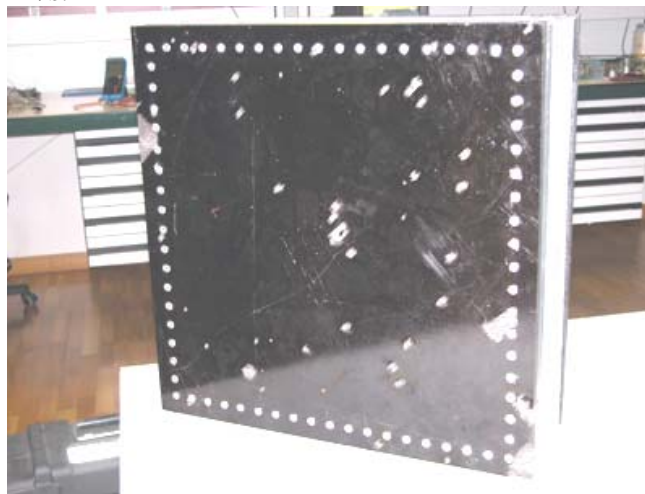
PHOTO 1: Front Panel after the Test.

- 48 impacts on the front panel (27 belong to the fragmented cubes and 21 to other kind of fragments).
- All fragmented cubes perforated the first panel. However, only 13 had penetrated in the back panel, other 5 had previously impacted on the rivet or on the edge of the front panel and did not impact on the back panel, and the last 9 had been significant hits but no complete penetration. All of them were easily recollected.
- The front face of the first ballistic panel displayed a smaller detached area than the corresponding back face detachment.
- The 13 out of 27 impacts with complete penetration have scored penetrations between 3 and 9 mm on the back panel.
- The fragments were not deformed as a consequence of the penetration.
- The spars were impacted and deformed but only locally, and provided enough protection to the back panel.

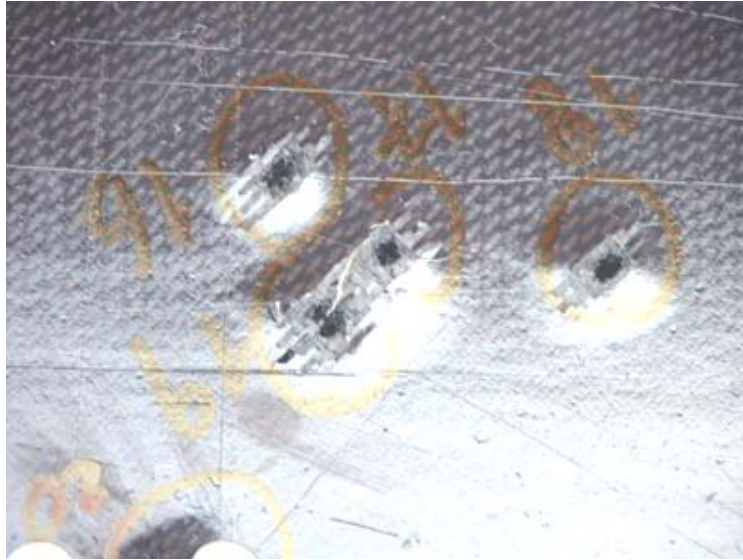
PHOTO 2: Front Panel after the Test: Detail of impacts.

The post-test analysis showed that the cracking pattern is typical of the high velocity ballistic impact. It is known that the CFRP has poor resistance to high energy impact due to the low strain to failure and the low transverse shear strength of the graphite fibre, as much as the brittle characteristics of the epoxy matrix.

The analysis of several impacts showed that the delamination between plies was larger on the first plies, reduced in the middle and increasing toward the back face. Delamination extended a bit away from the point of impact and the damage on both the upper and lower surfaces of the front panel was clearly visible.

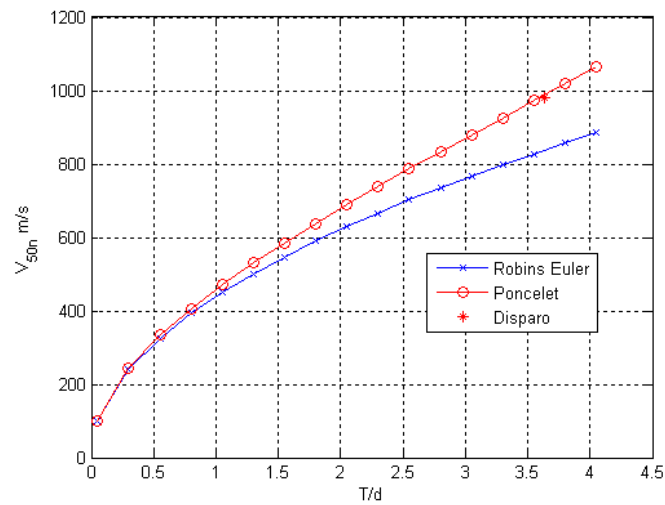
FIGURE 3: Estimated Ballistic Limit Velocity vs Laminate thickness/eq diameter

Two more analytical methods (Poncelet and Robins-Euler, see reference [5]) had also been applied (Figure 2). It is possible to see that the model of Poncelet seems to fit correctly.

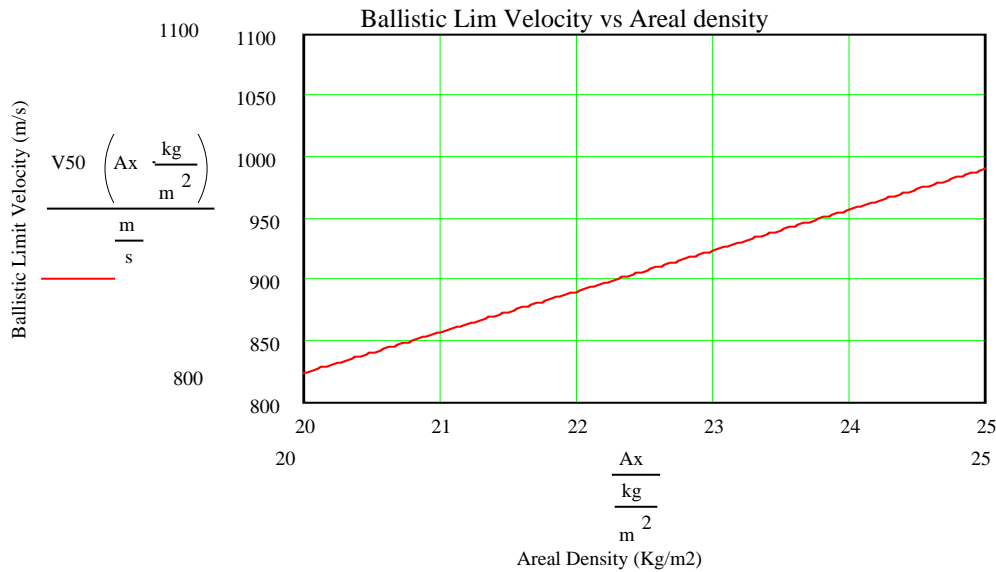
FIGURE 4: Estimated Ballistic Limit Velocity versus Areal Density

In the same way it is possible to study the relationship between the ballistic limit velocity and the areal density, even although it is only valid in a small interval (Figure 4).

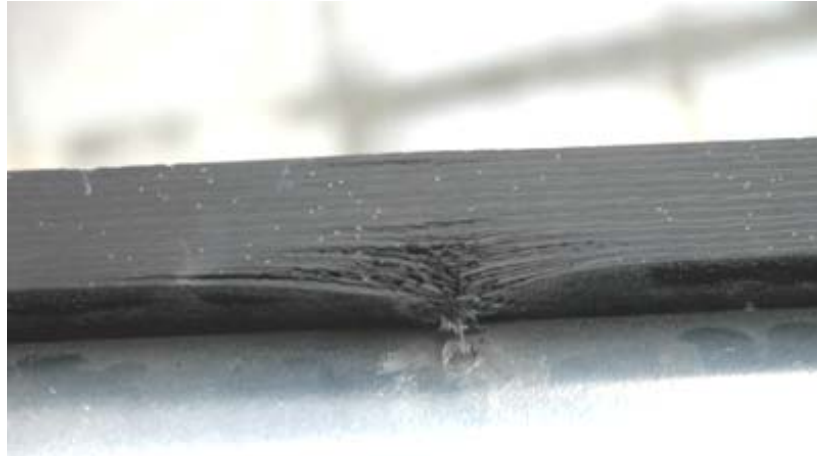
Photo 3 shows an impact (partially only) just in the edge of the panel, it is possible to see the shear plug near the front panel surface, the diameter of the shear plug is close to the diameter of the projectile on the first ply and increasing slightly with depth. The shear plug depth is close to 30% of the panel thickness.
