## Wire fence as applique armour

In this paper, the behaviour of wire fence was investigated for potential as applique armour. The wire fence used was made from commercial high-strength patented wire and the supporting frames were made of mild steel L-profiles. Both patented wire and L-profiles are of-the-shelf materials. The fence was tested by firing 12.7 mm M8 API ammunition at four applique armour models: two of these models use a parallel wire arrangement, with one mounted at a 90° angle from the incoming projectile and the other at 70°; and two of these models use a zig-zag wire arrangement, one mounted at a firm 90° angle and the other is left in a hanging arrangement. Fence damage was correlated with RHA basic plate damage, on both the face and back. Wire fence has considerable potential as an improvised applique armour, except if the projectile impacts near the center of the wire or near the center between two wires. The latter case was successfully overcome by placing the armour model at an angle and by using a zig-zag wire arrangement. The lowest basic RHA plate damage level was found using the hanging armour model. However, from the point of view of ease of attachment,

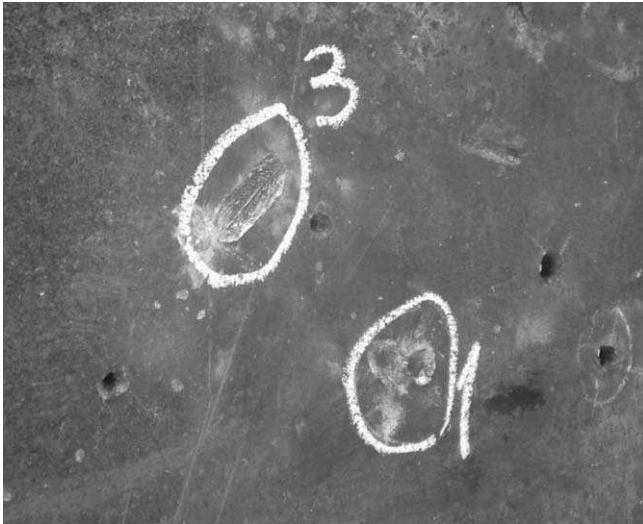
Fig. 8. ZSV-3 (marked as 3) and ZSV-1 (marked as 1).

In Fig. 7, two impacts of API penetration core (PSV-1 and PSV-4) on the basic RHA plate face are shown. Two cores impacted sideways as the result of passing through the wire fence. In Figs. 7 and 8 (impact marked as 3-ZSV-3) a typical elongated dent on

the RHA plate face are shown, as the result of sideways impact on the RHA plate. However, in Fig. 8, the dent marked as 1 (ZSV-1) shows the penetration that still occurred, as the result of

In the case of ZSV-4, the projectile impacted one wire, deformed and fractured it. However, the resulting damage on the basic RHA plate revealed not one elongated dent (Fig. 7) that occurs on other occasions (smooth and cracked bulge), but two (Fig. 8a). These two dents appear to be as one. However, there are clearly two very close dents with two depressions in the basic RHA plate. There is no evidence that the penetrating core of the projectile fractures after the impact on the patented wire, continuing towards the basic RHA plate in two pieces. Such a phenomenon occurs as the result of the bending stresses that are induced by edge impact [18]. The core, must be made of steel with a very high hardness, because it is necessary to provide the needed rigidity during the penetration process. However, it inevitably has low ductility. Therefore, such a core may be broken if a sufficiently hard and rigid edge is impacted. An answer to this occurrence may be given by analyzing one recovered penetrating core (PS20-2), with an obvious crack that has not propagated through the whole cross-section of the core (Fig. 9). Such a crack developed after the impact into RHA plate. This indicates that on other occasions (such as ZSV-4), a similar crack may have propagated through the whole cross-section. If the damage levels on the fence of PS20-2 and ZSV-4 are compared (Fig. 8a and b), it might be noted that it is more severe on ZSV-4, since a portion of the mild steel frame has been damaged. However, ZSV-4 is an “exception to the rule”, due to the fact that only 30.5% of the add-on armour model is covered in mild steel L-pro-

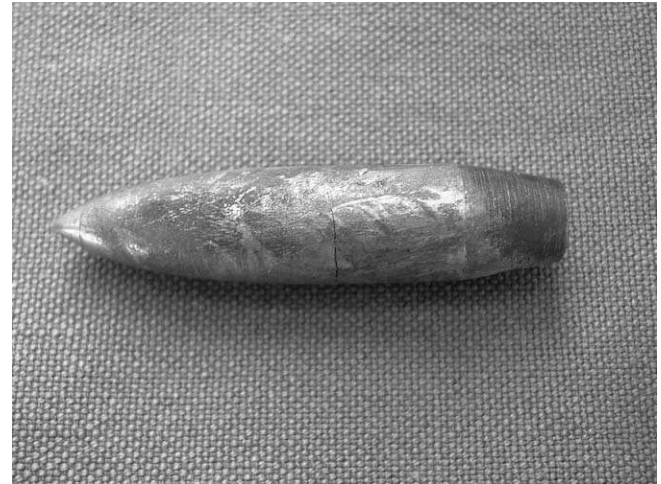
Fig. 10. Fractured core of M8 API ammunition used in PS20-2.

an insufficient yaw angle – the dent is elongated, but with a penetration that nevertheless occurred. In Fig. 9, there are two distinct damage levels on the fence – in both cases the projectile impacted one wire, but on various heights in relation to the mild steel frame. Furthermore, in Fig. 9a (ZSV-4), the fractured wire can be found along with damage to one part of the horizontal segment of the frame, while in Fig. 9b (PS20-2), only the vertical wire that was fractured can be seen. As the result of previous fence impact, the core of the projectile may even fracture (Fig. 9a). This is also shown in Fig. 10, where the M8 API penetrating core was extracted with a clearly visible crack that has not propagated through the whole cross-section of the core (PS20-2).
