IMPACT ON GLASS LAMINATES

S. J. Bless, T. Chen, and R. Russell

Institute for Advanced Technology, The University of Texas at Austin

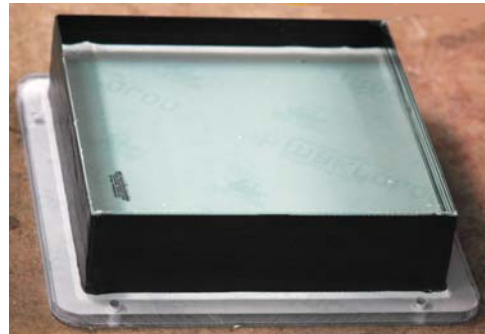
Fig. 1. Seven layer glass target. Glass outside dimensions are 304×285 mm. The seven-layer target contained 76 mm of glass on 12.7 mm of polycarbonate.

Two targets were tested: a four-layer target and a seven-layer target. Glass layers were bonded with about 0.6 mm of polyurethane. The four-layer target was 267 mm square, and the total thickness of glass layers was 31 mm, backed by 5.8 mm of polycarbonate. The edges of the glass were taped, but the tape was removed on one side to facilitate high-speed photography. The targets were held in place with a steel clamp on the plastic layer surface. The seven-layer target is shown in Fig. 1. Both targets were fabricated by Secur*Glass in Dallas, Texas. The glass used in this target was commercial soda-lime glass.

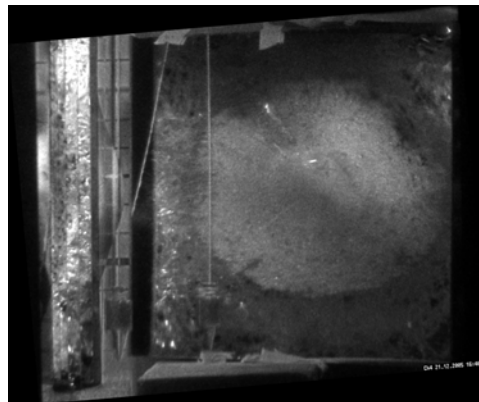
Fig. 5. View of target at 300 μs .

When this target was recovered, all of the layers were flat, but there was a gap between the fourth glass layer and the polycarbonate, into which many glass particles had become wedged. The last high-speed camera frame, at 300 μ s, shows the plastic has bulged by about 6 mm (Fig. 5). This bulge recovers, but the transient excursion allowed glass blocks to fall out of the fourth plate. The rear view at that times shows the outer regions of the first plate are cracked into a mosaic pattern, which was also seen in the recovered target.

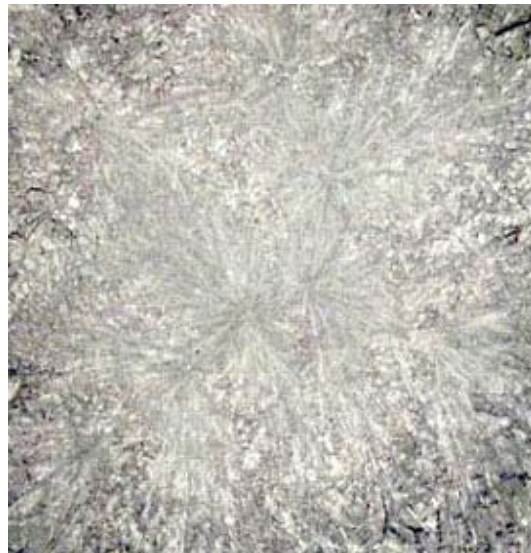
Fig. 8. Central damage pattern in the last layer of glass, viewed through the polycarbonate.

However, in the last layer of glass, as viewed through the plastic layer, the central damage pattern appeared homogeneous and composed of many millimeter-scale starburst patterns—termed *florets*—shown in Fig. 8.
