## THE EFFECT OF MATRIX TYPE ON THE BALLISTIC AND MECHANICAL PERFORMANCE OF E-GLASS COMPOSITE ARMOUR

W. Wong\*, I. Horsfall, S.M. Champion, C.H. Watson

Composite materials used as a spall lining in armoured fighting vehicles (AFV) must have good ballistic qualities as well as structural characteristics that can withstand applied loads, before and after impact. This paper investigates whether there is a relationship between ballistic and mechanical properties of glass fibre reinforced plastic material. Impact damage on the composite panels was caused by ballistic and drop-tower tests using .30 calibre fragments at 500 to 700 m/s and a Rosand machine at 50 J impact respectively. An ultrasonic C-scan determined the subsequent delamination size, which was expected to be inversely proportional to the Mode I experiments determining the delamination resistance ( $G_{1C}$ ). The results showed a slight relationship between three composite panels, where reduction in  $G_{1C}$  followed an increase in ballistic properties.

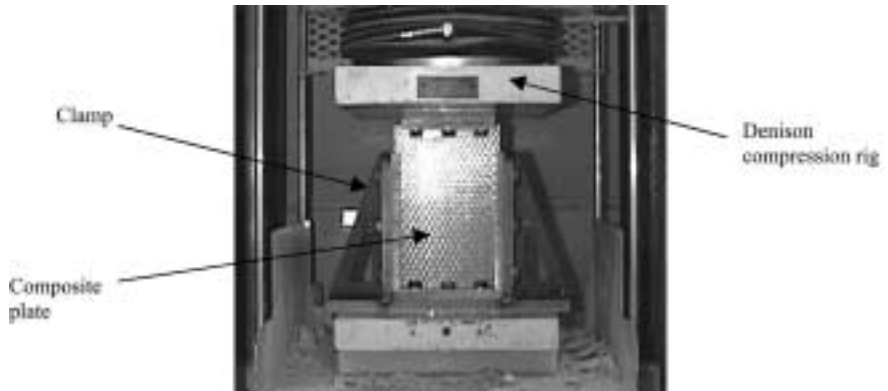
As structural behaviour after impact was an issue, compression after impact (CAI) tests were performed using a Denison compression rig where maximum load endurance is 3000 kN.

Figure 1: CAI Test Apparatus.

During the CAI tests, cracking sounds due to fibre breakage were heard, except in the phenolic resin sample where complete fracture followed only a few fibre breakages. All the failures were situated at the centerline of the composite panel (perpendicular to the line of force) and through the impact point.

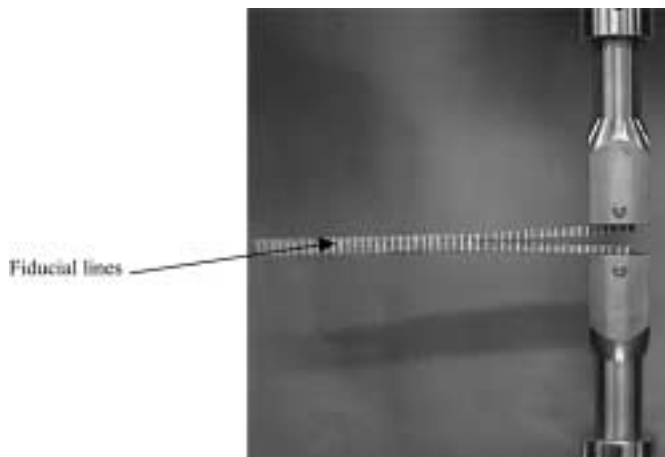
As Cantwell and Morton [1] discovered delaminations were one of the primary damage failure modes after impact, double cantilever beam (DCB) mode 1 delamination resistance tests were carried out adopting the experimental compliance method. Composite strips of 250 mm x 25 mm x 12 mm were marked at 5 mm intervals and load blocks were glued to the sides. This apparatus is shown in Figure 2.

Figure 2: Mode 1 Delamination.

A PolyTetraFluoroEthylene (PTFE) starter film inserted during manufacture was used to provide crack initiation. With the Instron machine, load (P) vs. displacement ( $\delta$ ) was achieved (see Figure 3) and the load at each 5 mm crack propagation interval was recorded. Compliance (C) was then determined by equation 1.

When following the progress of the crack in the DCB mode 1 experiments, the crack tended to propagate through two to four fiducial lines concurrently, but other than this, the advancements were quite steady.

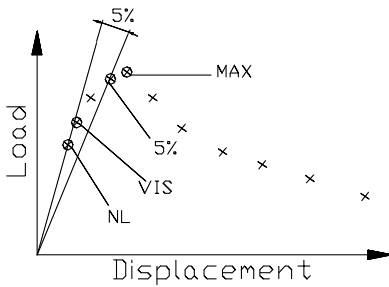
Figure 3: Load vs Displacement.

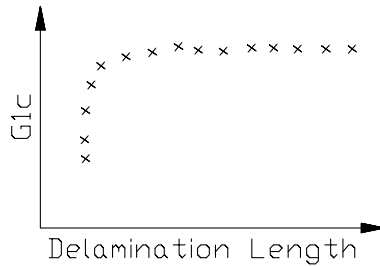
Figure 4:  $G_{1C}$  Results Presentation.

$G_{1C}$  can then be plotted as seen in Figure 4 and its value can be taken by reading the average value of the plateau.

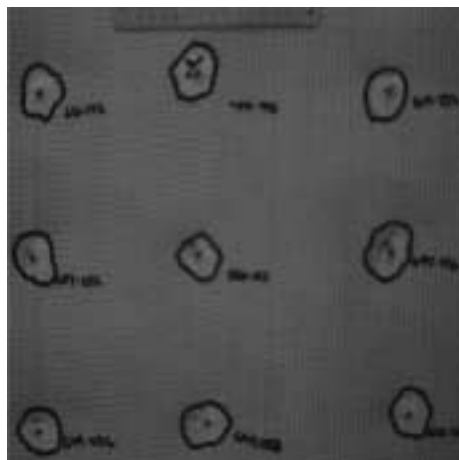
Figure 5: Front Face of Epoxy Ballistic Panel.

From visual inspection, the front face of the ballistic panels displayed a smaller detached area than the corresponding back face detachment. In all cases, the delaminated perimeter spreads out from the central impact point and surface cracking was seen near the vicinity of all the projectile entrances. The front face of the ballistic panels showed “tufts” of fibre protruding away from the projectiles point of entry. Similarly, these were also located where the projectile had exited. Back face observations showed that the smallest and most localised detachment areas were from the epoxy panel whilst emerging adjacent delaminations occurred in all the phenolic matrix samples. When the detached areas on the back face of the phenolic resin and the resin with 10% PVB panels were gently depressed, these areas sprang back to a greater extent than similar areas on the other panels.

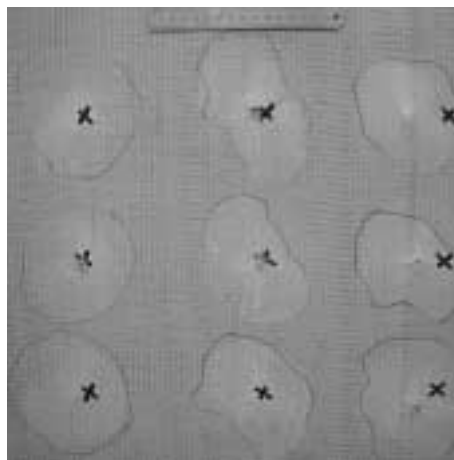
Figure 6: Back Face of Epoxy Ballistic Panel.

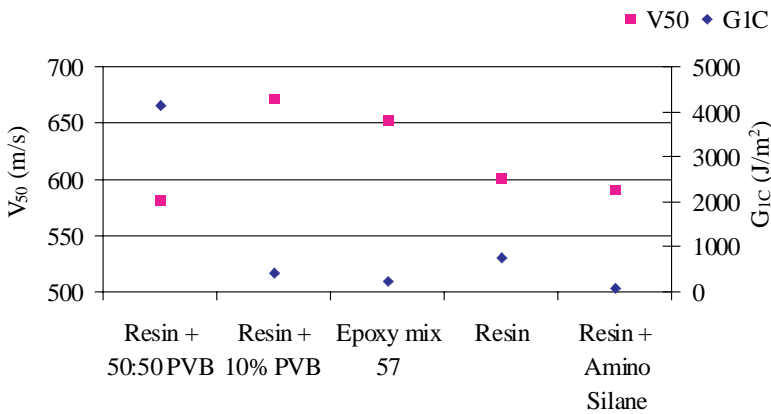
Figure 7: Comparing  $G_{1C}$  and  $V_{50}$  Results.

Figures 7 and 8 shows the trend of the results. It was predicted that the delamination resistance test data would be approximately proportional to the CAI test and inversely proportional to the C scan results. Unfortunately, the data does not show such a trend. However, there is a slight inverse relationship between the ballistic properties and the resistance to delamination. Also, Figure 8 illustrates that as delamination area increases, the CAI maximum load reduces.

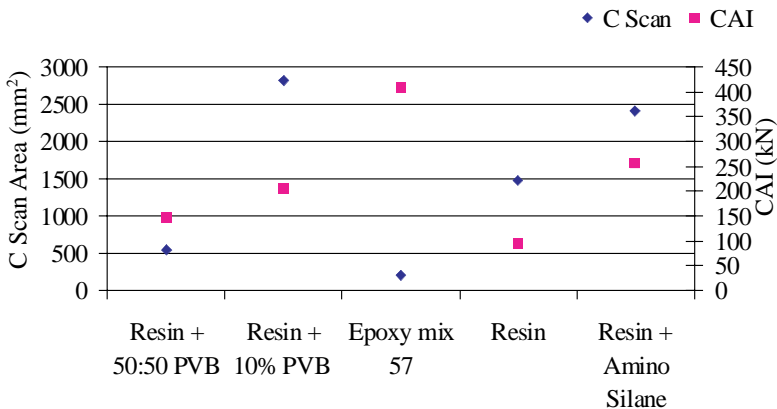
Figure 8: Comparing Delamination Area and Maximum CAI Load.
